Technical Note

Project title Greystones Harbour PPP
Job number 284532-00
File reference TN001
cc
Prepared by Sean Mason
Date 8 February 2024
Subject Coastal Erosion along North Beach

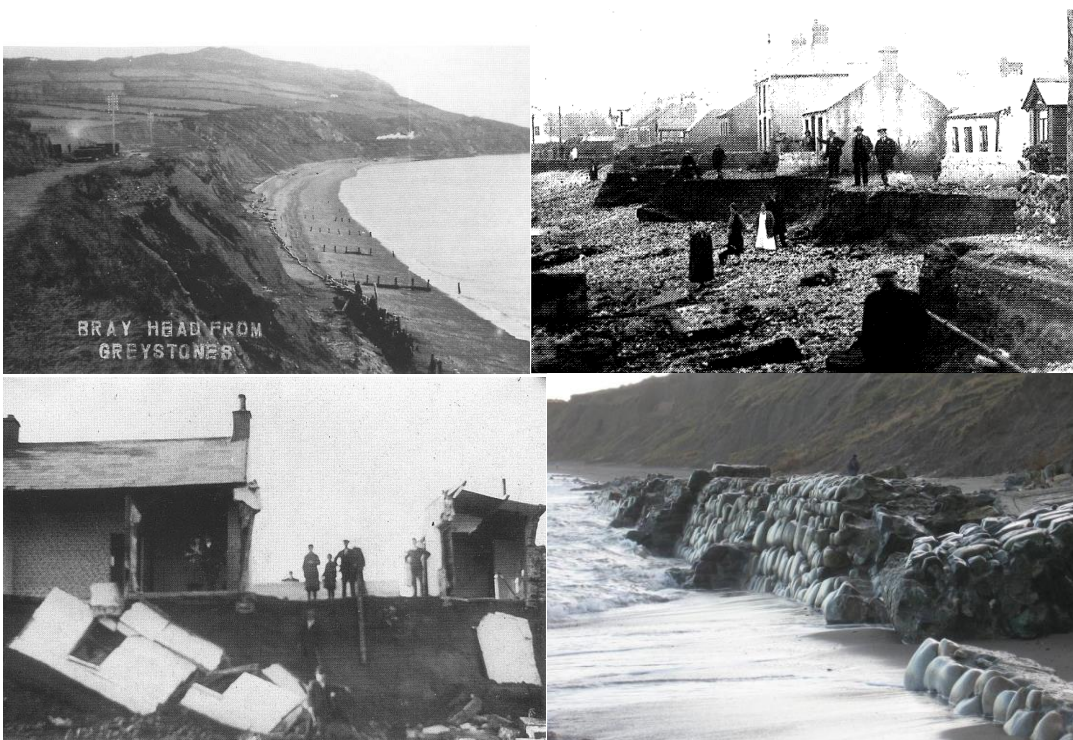
The beach north of Greystones has been eroding for centuries and will continue to erode into the future, until a stable beach profile is achieved within the coastal 'cell' between the rock headlands at Greystones and Bray Head. Studies of historical data undertaken by Arup indicate average erosion rates of up to 0.5m a year over the last decades for which data is available. The 2020 Irish Coastal Protection Strategy Study (ICPSS) forecasts erosion rates up to 1 to 2m per year. Erosion of the cliffs along the north beach is caused by the action of the sea and the seepage of rainwater through the face of the cliffs. The emerging impacts of climate change from increased intensity weather events, metocean events and rising sea levels are likely to cause increased erosion.

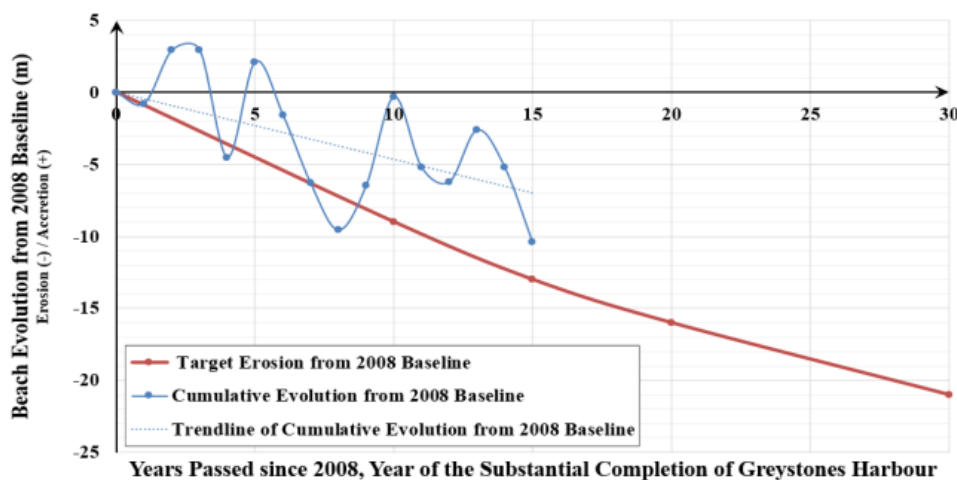
Figure 43 Evolution of the 0mOD contour at the CPO Boundary in relation to the target erosion

There has never been any objective or intention to stop erosion of the north beach, as it is not a sustainable solution. The ‘managed retreat’ approach is achieved by monitoring erosion every year, implementing beach management measures (mainly beach nourishment using imported shingle) to slow down erosion as required. The concession agreement provides details on the beach management strategy that has been implemented by Sispar, guided by the annual beach monitoring reports prepared by Arup. A location in the central region of the beach (at the CPO boundary) was selected as the point to monitor the actual erosion each year for checking against that allowed. Since completion of the works in 2006 the measured erosion has been well within the limits at the point of measurement, as shown below in the graph up to and including last year 2023. The graph shows the extent of erosion or accretion year-on year. When the erosion has reached the target line Arup have recommended and Sispar have implemented beach nourishment works as required. The graph shows increased erosion over the past 2 years, with more erosion likely as a result of recent storm events. Based on this reliable monitoring information the draft 2023 beach monitoring report recommends placement of beach nourishment this year in 2024.

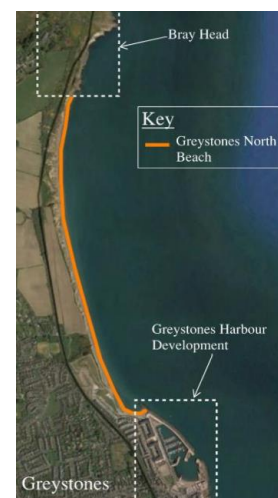
It is evident that the most significant cliff erosion has occurred in the area immediately north of the rock revetment structure. This is due to a combination of factors, including the scouring effect at the edge of the 'hard' revetment, the easily eroded fine sandy soil deposits in this location, and the seepage of rainwater through the cliff face. The enhanced erosion at the north corner of the revetment has partially exposed the toe of the revetment, and the loss of beach restricts beach access in front of the revetment to spring low tide periods only.

The cliff and beach erosion have also impacted the lower section of the access ramp leading down to the beach from the crest of the revetment. This is the only continuous and safe means of pedestrian access to the north beach, and therefore must be maintained. This access ramp has been periodically reinstated and extended over the years, but given the increased risk of more frequent impacts from waves and groundwater flow, works are required to help protect the ramp and maintain safe access over more sustained periods of time. Arup have been retained by Sispar to design and oversee implementation of these local access works. Careful planning and design is required to increase protection of the ramp while minimising the inevitable adverse impacts on the adjoining beach and cliff. It is planned to carry out these works over this year 2024. In the interim we understand that Sispar will implement short-term reinstatement measures to maintain safe pedestrian access. Note that the longer-term solution will have to facilitate the operation of trucks and earthmoving equipment (dozers) for future beach nourishment (shingle importation) works.

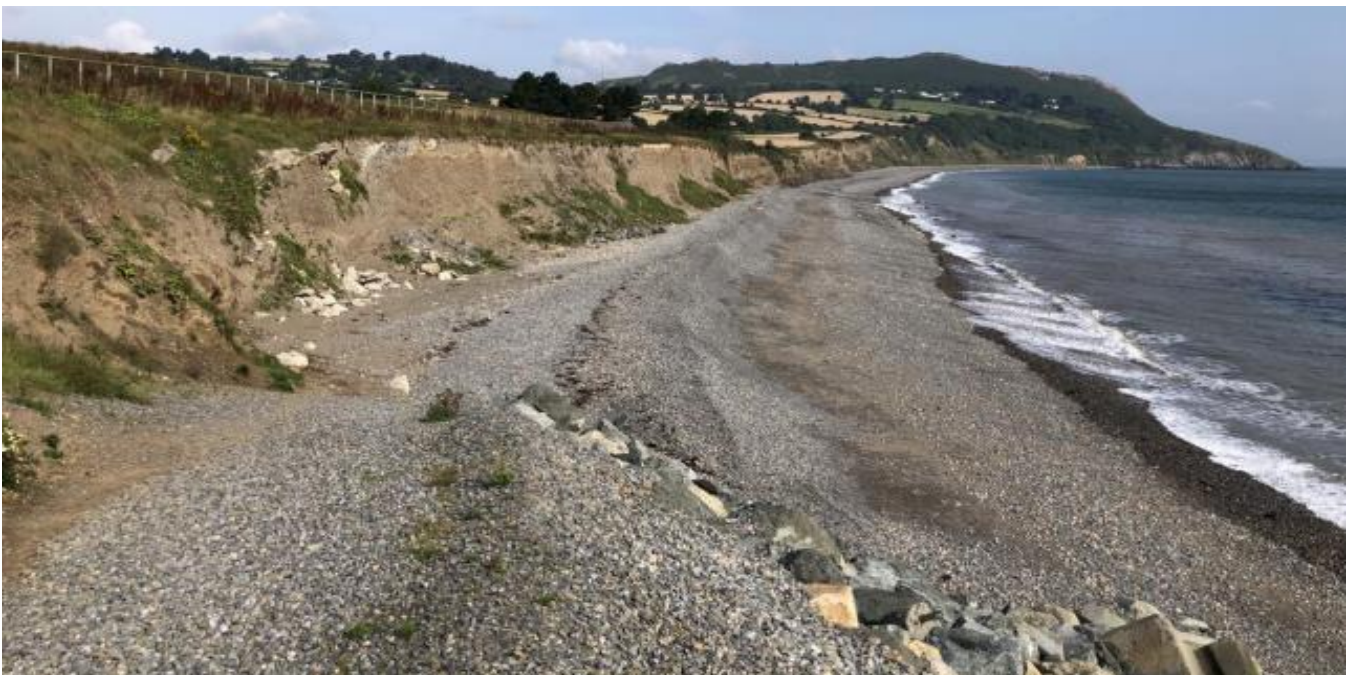
The ongoing beach management works will not stop erosion of the cliffs, which will continue in the area north of the revetment along the fenced-off park area. We understand the existing pathway outside the fence was a temporary access route provided during Covid, which will have to be removed given the ongoing cliff erosion in this area. The Cliff Walk route will be aligned through the park as originally designed and always intended. The potential loss of a narrow strip of park space along the cliff line due to erosion is inevitable and was always going to be allowed, so as to preserve the natural coastal environment as much as possible. The stopping of any further erosion of the park area would require the extending of the full rock revetment north of the landfill to the end of the park. This idea is entirely inappropriate as it would:

- Remove the natural cliff habitat and cover it with a revetment structure,
- Result in the complete loss of the beach due to enhanced erosion in front of the new revetment, hence removing the amenity value of this space,
- Result in significantly increased cliff erosion at the end of the new revetment and beyond, as it would be in a more exposed location. The rockfill groyne (finger) at the end of the marina provides some protection to the existing revetment and adjoining beach area from wave erosion, which would not be the case if the revetment is extended further north,
- Require a new pathway and ramp down the extended revetment to beach level, with increased erosion impacts, and
- Would come at a cost on the order of millions of Euros.

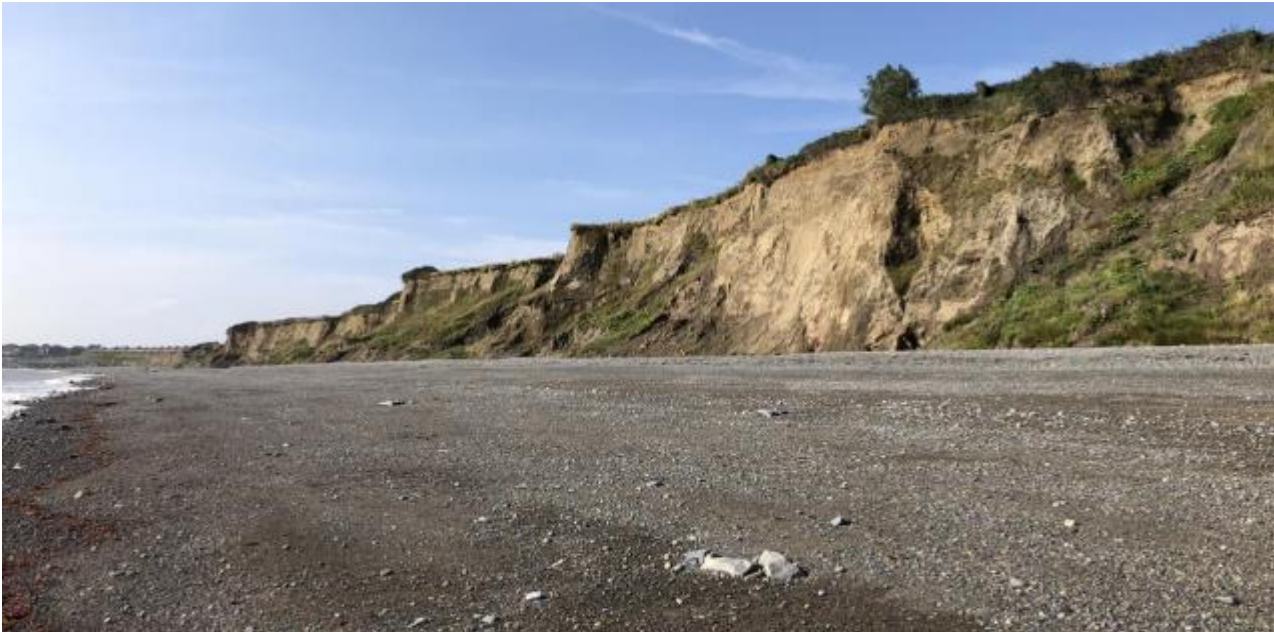
View of North Beach and cliffs from northern section looking back towards Greystones.

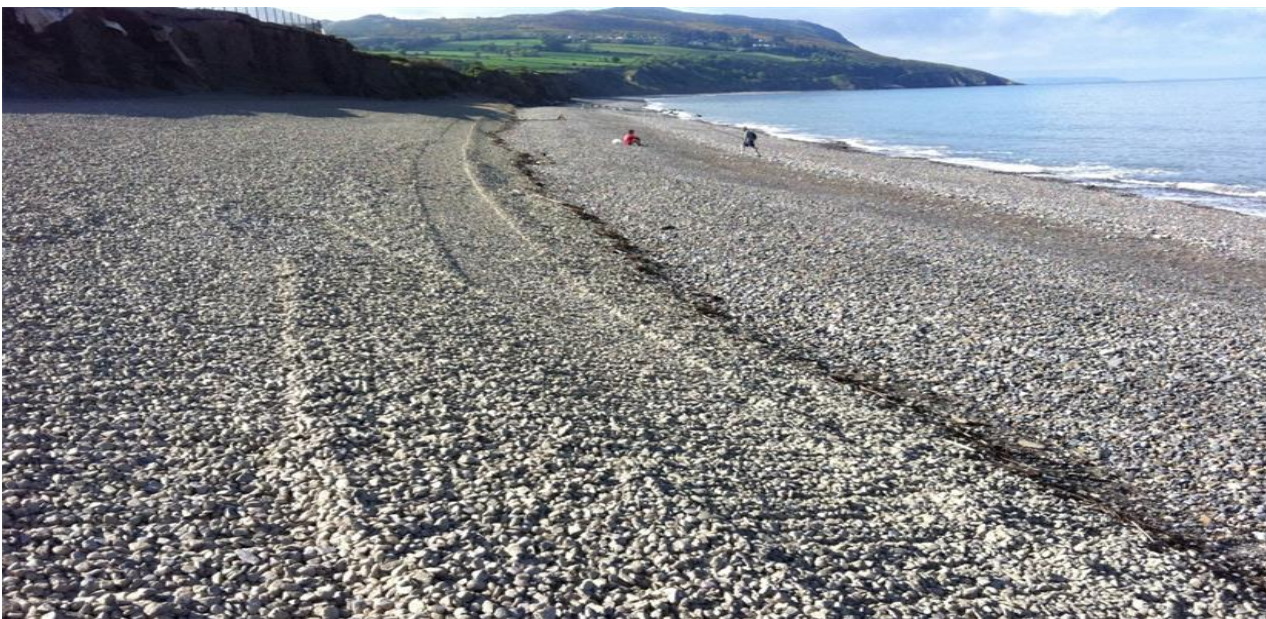
Completed beach nourishment works at Greystones North Beach. Site visit 25 May 2014
